# THIRD FIVE-YEAR REVIEW REPORT

## Bally Ground Water Contamination Superfund Site

Borough of Bally

Berks County, Pennsylvania

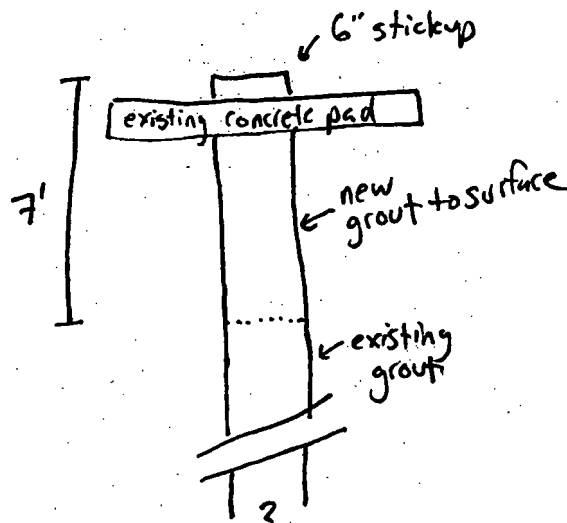
- Well had existing grout to ~7' bgs. Added approximately 1 bag of Portland Type I cement to ground surface and took pictures.
- Well located on [REDACTED] property
- Abandonment completed via signed agreement w/ [REDACTED]
